Warrego Energy PTY Ltd

West Erregulla 3D Seismic Survey

EPBC 2013/7054 Annual Report 2014-15

23 December 2015

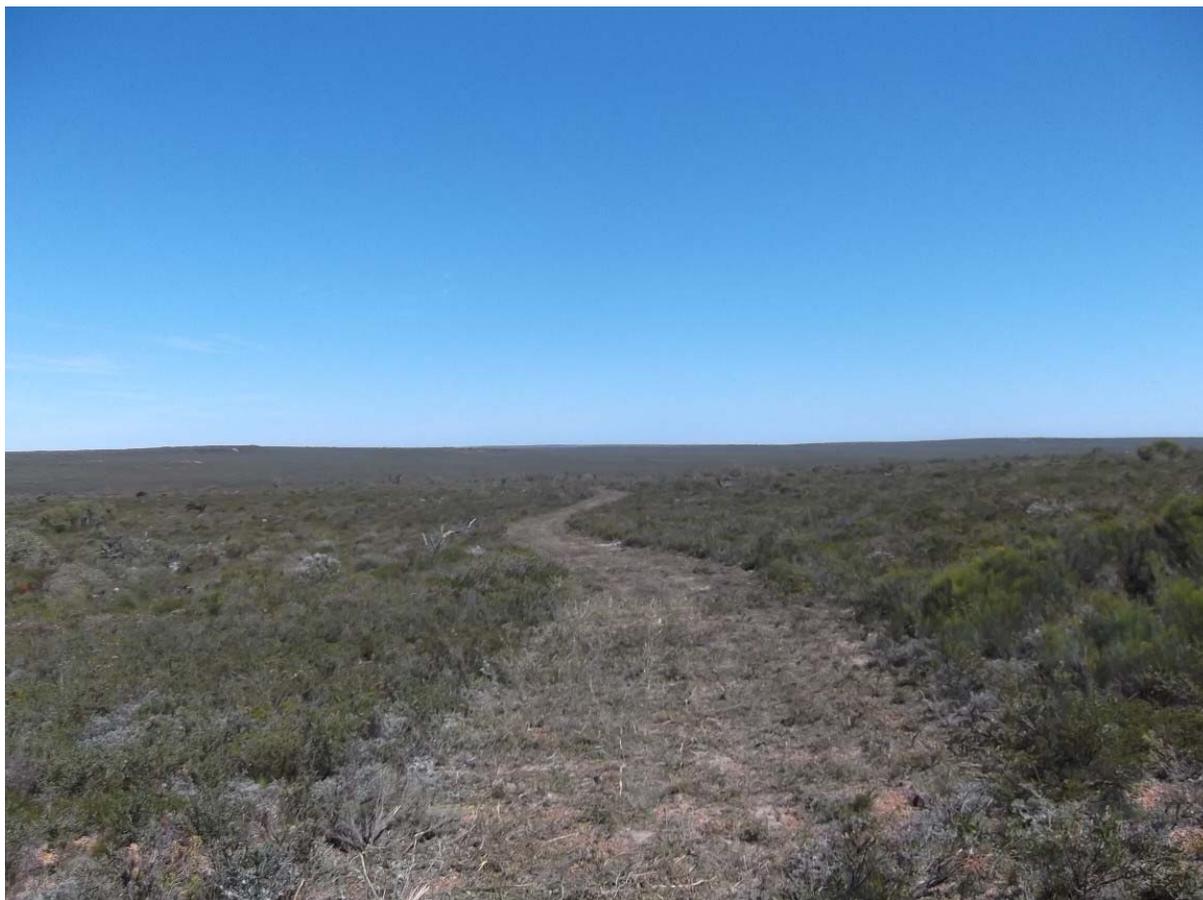
Plate 1 Seismic line cleared using raised roller mulching technique

<p>10. a. <i>Note: condition was deleted on 3 April 2014.</i></p>	
<p>b. Vegetation clearing along access tracks and 3D seismic survey source lines must not be scraped to bare earth.</p>	<p>A raised roller mulching technique was used to clear native vegetation. Cleared vegetation was mulched and spread behind the clearing machinery. Raised roller mulching clearing leaves the rootstock intact. No other clearing machinery was used as part of the seismic program.</p> <p>Refer to Plate 1 for an example of a track cleared using the raised roller mulching technique.</p>
