**Warrego Energy PTY Ltd**  
**West Erregulla 3D Seismic Survey**  
EPBC 2013/7054 Compliance Report  
20 January 2015

# West Erregulla 3D Seismic Survey

Prepared for  
Warrego Energy PTY Ltd

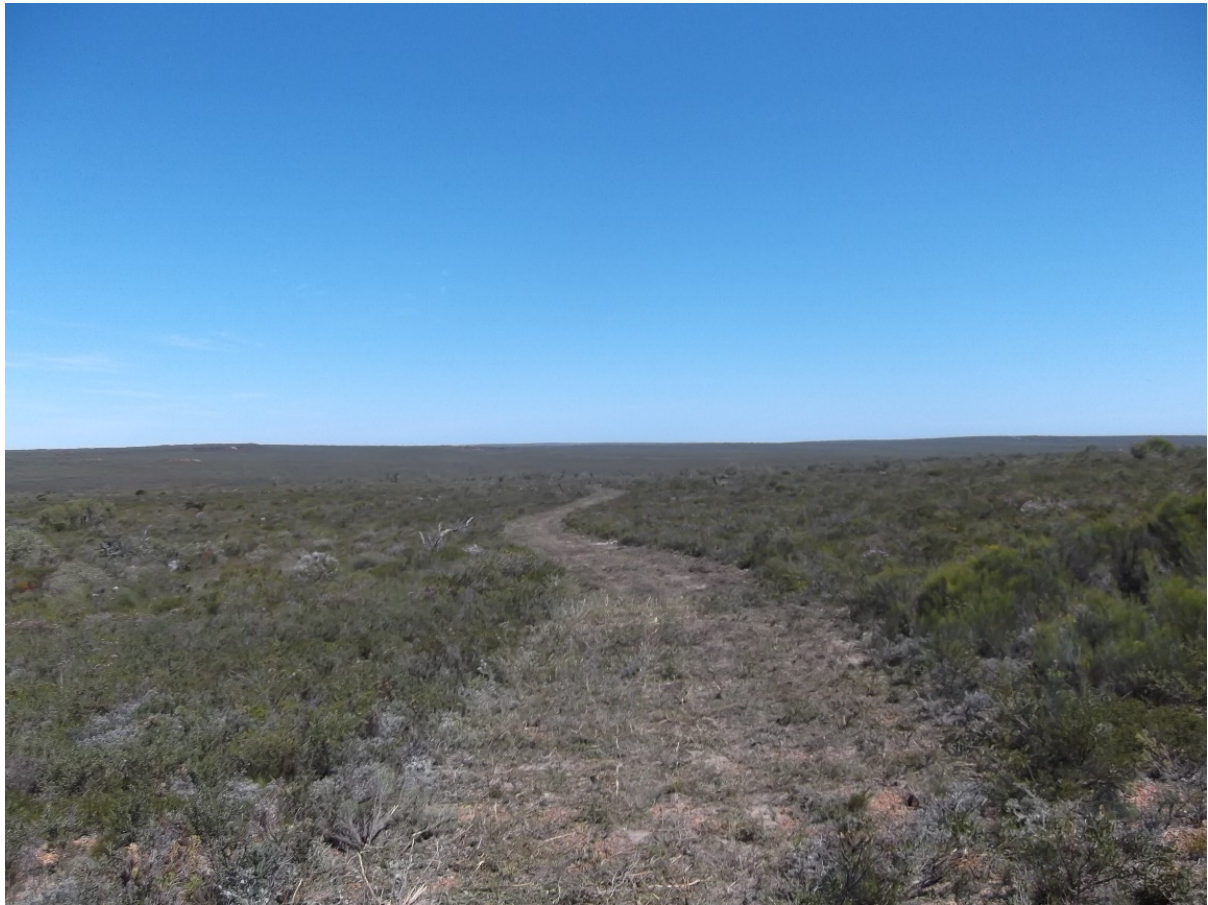
**Plate 1 Seismic line cleared using raised roller mulching technique**

<p>10. a. <i>Note: condition was deleted on 3 April 2014.</i></p> <p>b. Vegetation clearing along access tracks and 3D seismic survey source lines must not be scraped to bare earth.</p>	<p>A raised roller mulching technique was used to clear native vegetation. Cleared vegetation was mulched and spread behind the clearing machinery. Raised roller mulching clearing leaves the rootstock intact.</p> <p>Refer to Plate 1 for an example of a track cleared using the raised roller mulching technique.</p>
